Case Report

Inappropriate Shock Due to Subcutaneous Lead Body Fracture: Extraction and Reimplantation

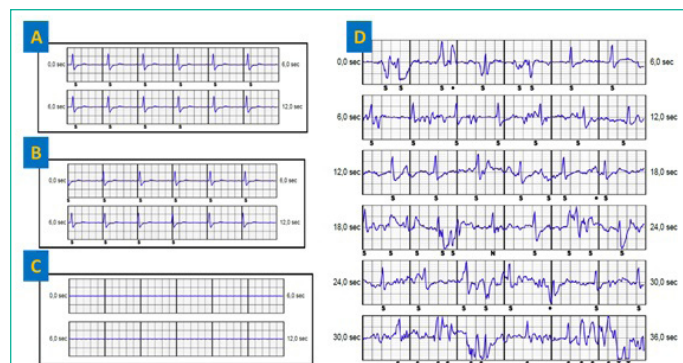
In July 2020, a 58-year-old man with an ischemic cardiomyopathy was implanted with an S-ICD in secondary prevention. 23 months later, the S-ICD delivered a therapy at night and the patient was called for follow-up. The examination revealed a high electrode impedance (>400 ohms) and 3 episodes classified as "ventricular tachycardia" of which one was treated.

The 3 events showed mechanical artifacts. S-ECG control reveals identical primary and secondary vectors and a flat alternate vector (Figure 1). Chest X-ray with front and left profile confirmed the lead rupture at the left xypho-sternal angle as described in the literature. The patient was asymptomatic and did not report any chest trauma.

Figure 1: (A) Primary vector. (B) Secondary vector, similar to the primary vector. (C) Flat alternate vector (D) event classified as VT showing mechanical artifacts.

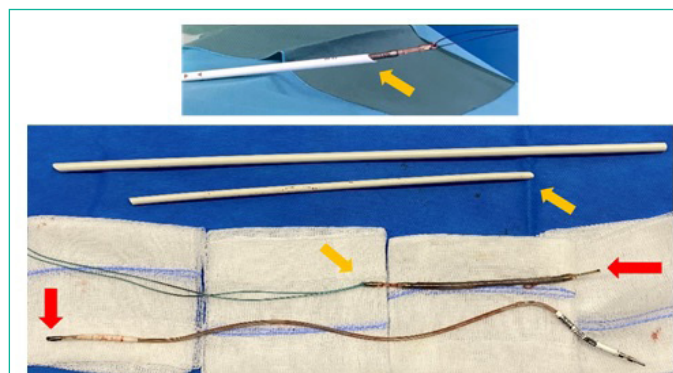
With a xyphoid incision, we were able to visualize a clear fracture immediately after the distal part of the proximal electrode. The proximal part of the lead was removed by simple traction without difficulties.

Figure 2: Top: extracted lead with the dilator sheath through distal incision.

Bottom: Lead extracted in 2 pieces thanks to the dilator sheath. Red arrows indicate the fracture point. In orange, the direction of extraction.

To avoid partial extraction of the remaining part, in particular unwinding of the coil [5], an additional incision in distality of the lead was made. A Cook dilator sheath (ref. G19860, internal diameter 11,5Fr, length 38cm) was used; this was adjusted to the remaining length of the lead. A solid thread was inserted into the hole at the end of the lead and then mounted in the extraction sheath, which in turn was inserted through the distal incision. The lead was freed from all adhesions by making push-pull between the lead and the sheath, supplemented by clockwise and counter clockwise rotations of the sheath.

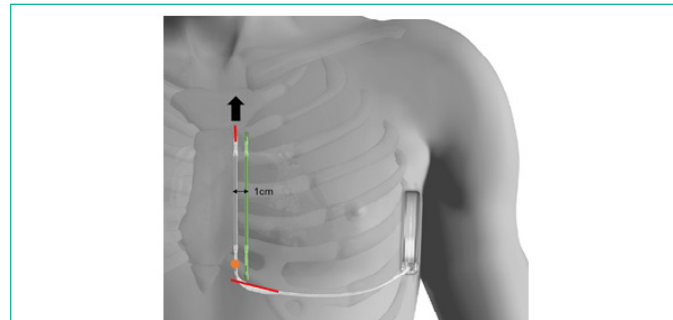
Figure 3: ●: Fracture point of the lead, distally to the proximal electrode

In red: The 2 incisions made

Arrow: Direction of extraction, through the supplementary distal incision

In green: New tunneling 1cm away from the initial lead

The detection parameters of the previous electrode were deemed appropriate. Therefore, the new device was also implanted left parasternal side. The additional distal incision made to extract the lead was closed to proceed to a classic 2-incisions implant technique. A new tunneling was carried out in parallel to the sternum, 1cm left away from the initial lead to avoid

any floating of the lead (Figure 3). The system was tested with success (65J, 74ohms, time to treatment 17s). The control X-ray shows good positioning of the device.
