Case Report

Management of a Complex Case using Conventional Complete Denture Restorations

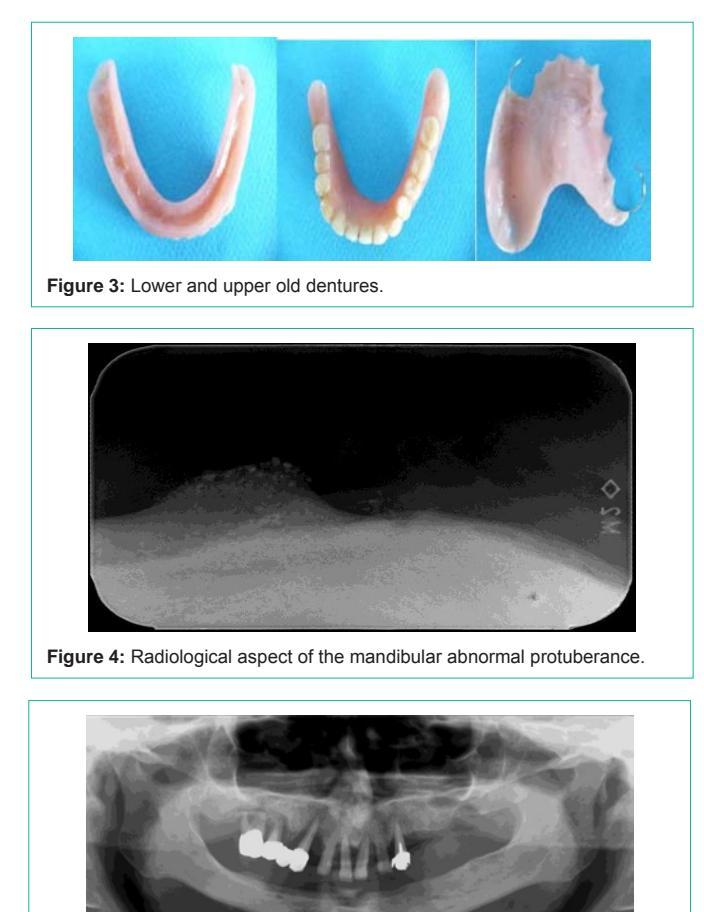
Figure 5: Initial OPG investigation.

The mandibular alveolar crest presented an increased resorbtion in the areas related to the opposing teeth, when the vertical position of the mental foramen and mandibular canal were taken as reference. In the alveolar area corresponding to teeth 46 and 47 a bone condensation and a protuberance is visible (Figure 5).

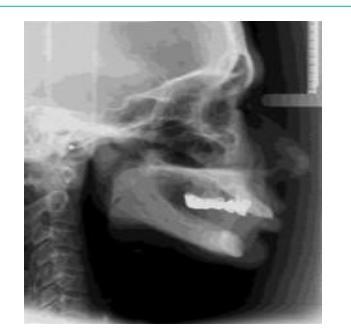
Figure 6: Lateral cephalometric radiograph.

The cephalometric evaluation with the old restorations in the mouth reveal an almost hypodivergent skeletal pattern (FMA=21), with an increased facial index (FI=0.8), which suggests an anterior rotation of the mandible. Other measurements also support the diagnosis of reduced vertical dimension and anterior rotation of the mandible: GoGn – SN (30 as compared to a normal value of 32), NsaNsp-M (17, normally 28), NsaXi-XiPM (36, normally 43), Nsa-Me. Angular measurements show a normal position of the maxilla and mandible in relation to the cranial base.

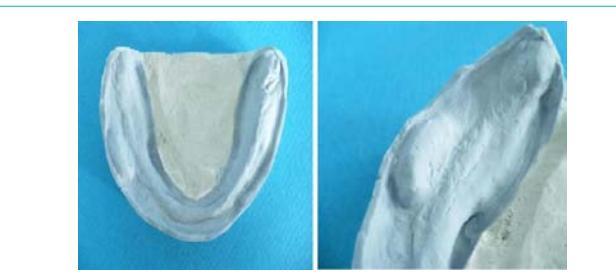
Figure 8: Mandible master cast.

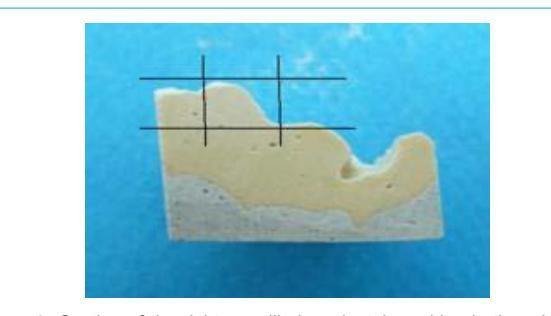
Figure 9: Section of the right mandibular edentulous ridge in the middle of the protuberance.

(SNA=81, SNB=78). ANB angle indicates a relatively normal skeletal relationship between the maxilla and mandible (ANB= +3). However, using McNamara analysis, a prognathic position of the mandible could be determined. (Pg is located anteriorly of N FH) and a lower lip prominence (LI-E line has a positive value) (Figure 6, 7). The mandibular master cast revealed the protuberance in the right buccal sulcus. The right side of the residual ridge is significantly smaller than the left ridge (Figure 8, 9). The master casts were duplicated and sectioned for a better evaluation. The sections better reveal the protuberance's dimensions (Figure 9, 10).

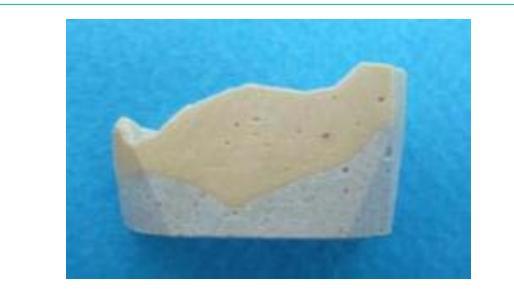
Figure 10: Section of the right mandibular edentulous ridge distal to the protuberance.

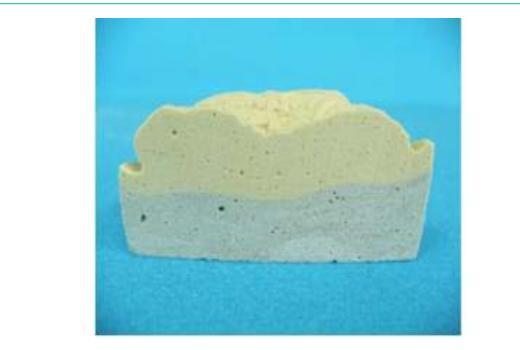
Figure 11: Right side undercut at canine.

Another anatomical particularity was represented by the maxillary undercuts well represented at canine and retro-zygomatic process areas (Figure 11, 12).

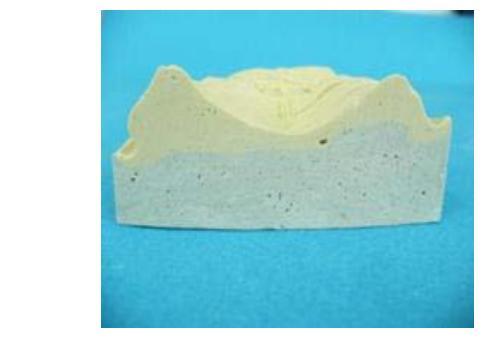
Figure 12: Posterior right side undercut level.

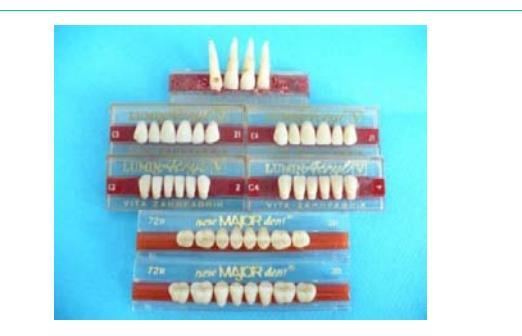
Figure 13: Extracted natural teeth and the set of artificial teeth.

Maxillary extracted teeth were used for a better choice of the artificial teeth [12, 13]. Color, shape and dimension are factors to be accounted when artificial teeth are chosen (Figure 13). Fortunately, we found an appropriate set of very small teeth in our artificial teeth collection.

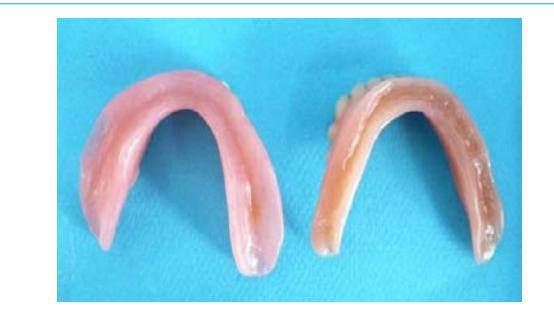
Figure 14: Comparative aspect of the old and new denture.

The new complete lower denture covers the abnormal protuberance, adding significantly to the muco-osseous support of the prosthesis. Denture flanges were designed following the principle of maximum physiological extension (Figure 14, 15).

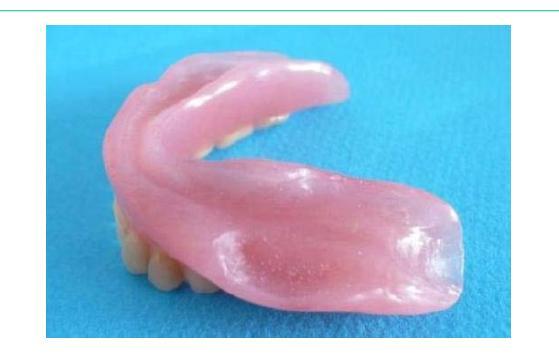
Figure 15: Extension of denture base over the mandibular protuberance.

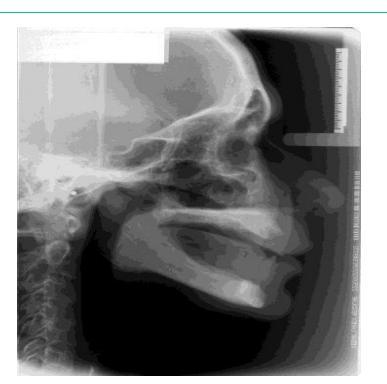
Figure 16: Post-treatment lateral radiograph.

from 21 to 24). There are no significant changes in the position of the maxilla. (< SNA and BaNA present minor changes). The augmentation of VDO led to the posterior rotation of the mandible, which increased the < ANB to +5, since the SNB value modified from 78 to 77. The lips have a normal position (Li-E line becomes negative). The profile is normal convex because of the posterior rotation of the mandible and the increased VDO. (Figure 16,17).
