## **Case Report**

# Accessory Breast Tissue in Axilla Miming Lymphadenopathy in a Patient with Ovarian Tumor

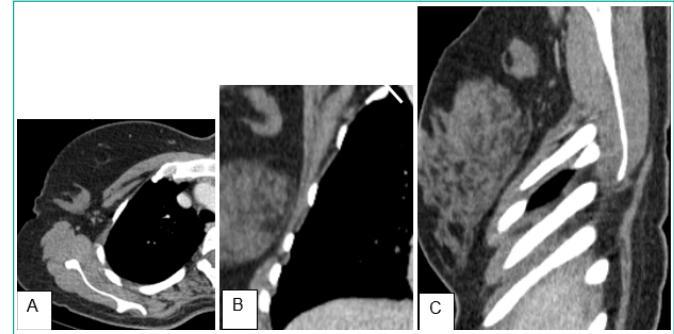
**Figure 1:** CT finding of the right axilla: (A) Axial (B) Coronal and (C) Sagittal Ct images depicting a right axillary lesion resembling a lymph node (arrow).

We report the case of a 42-year-old female patient with an ovarian tumor who was referred to our radiology center for preoperative imaging, including chest, abdominal, and pelvic CT scans. The CT scans did not reveal any evident metastases, except for an abnormal right axillary lymph node.

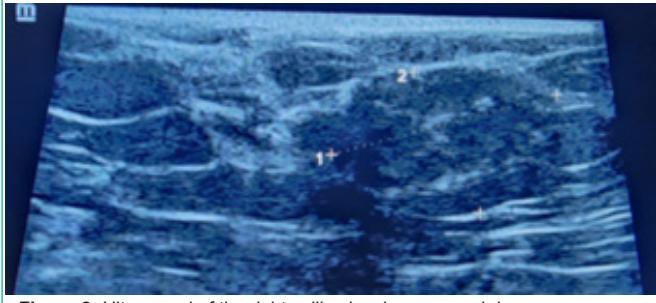
Figure 2: Ultrasound of the right axilla showing a normal dense fibroglandular tissue which is not connected to the pectoral breast tissue.

To further characterize the finding, an ultrasound of the axillary lymph node was performed. The ultrasound revealed normal dense fibroglandular tissue that was not connected to the pectoral breast tissue. No solid or cystic mass lesions were present. These findings were consistent with accessory breast tissue.
